Reference: EPA Contract No. 68-W9-0040; Work Assignment No. R05-25-02; American Steel Foundry (ASF) Production Facility and ASF Disposal Facility, Alliance, Ohio; EPA I.D. Nos. OHD981090418 and OHD017497587, respectively; Preliminary Assessment/Visual Site Inspection; Final Deliverable

Enclosed please find the Preliminary Assessment/Visual Site Inspection (PA/VSI) report for the above-referenced facilities. The report presents the results of the Preliminary Assessment (PA) and Visual Site Inspection (VSI) for the facilities.

American Steel Foundry Production and Disposal Facilities  
Alliance, Ohio  
EPA I.D. Nos. OHD981090418 and OHD017497587

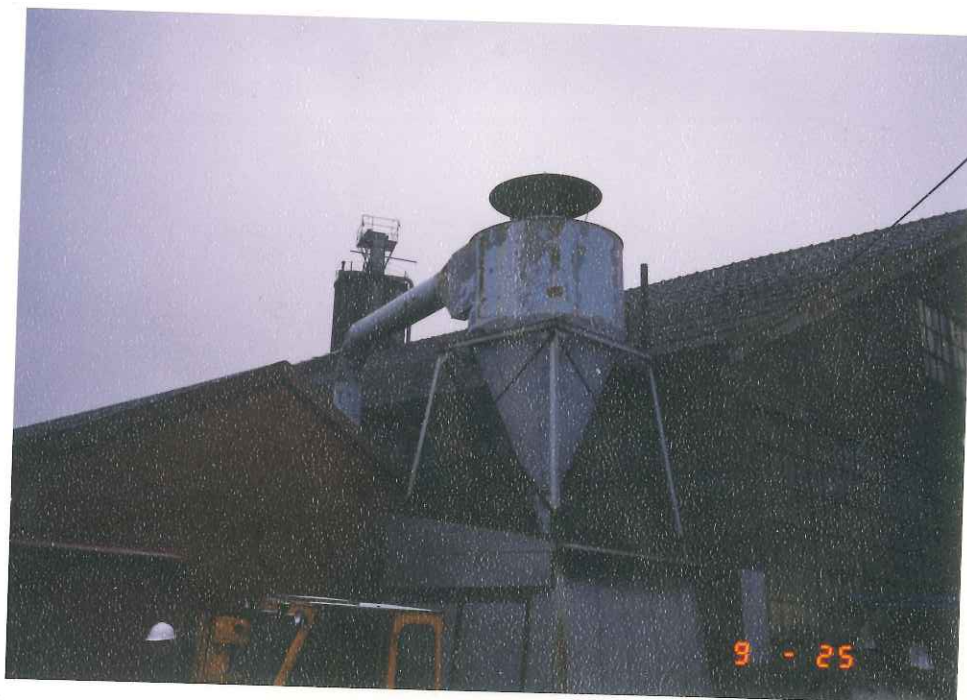
Photograph No.: 1  
Date: January 14, 1993

Description: Overview of Pattern Shop Baghouse (SWMU 2).

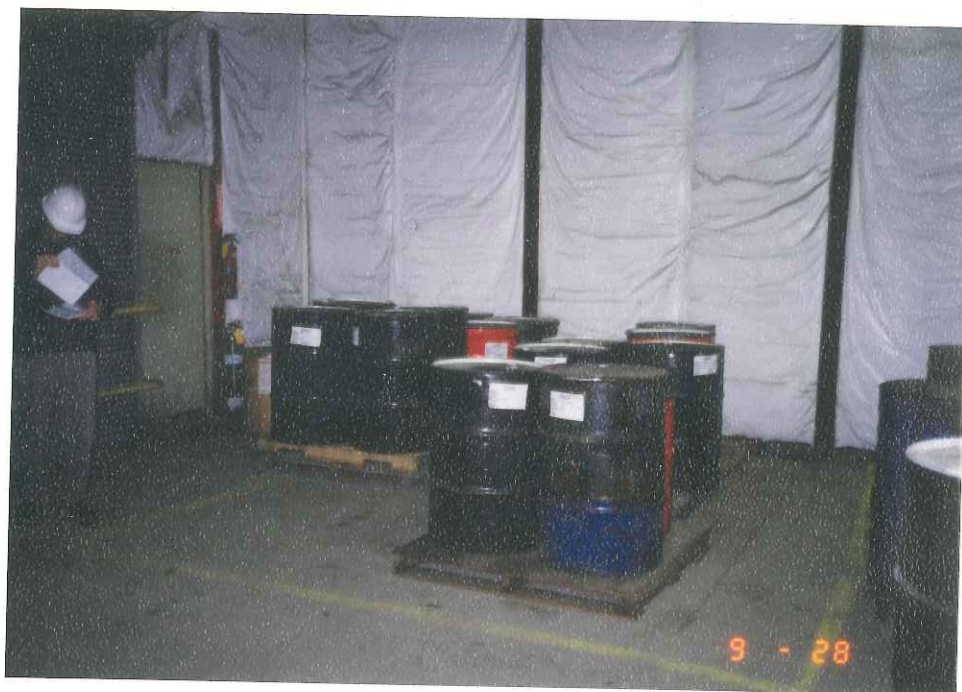
Photograph No.: 2  
Date: January 14, 1993

Description: Close-up view of Container Storage Area (SWMU 7) located within the flammable materials storage building.

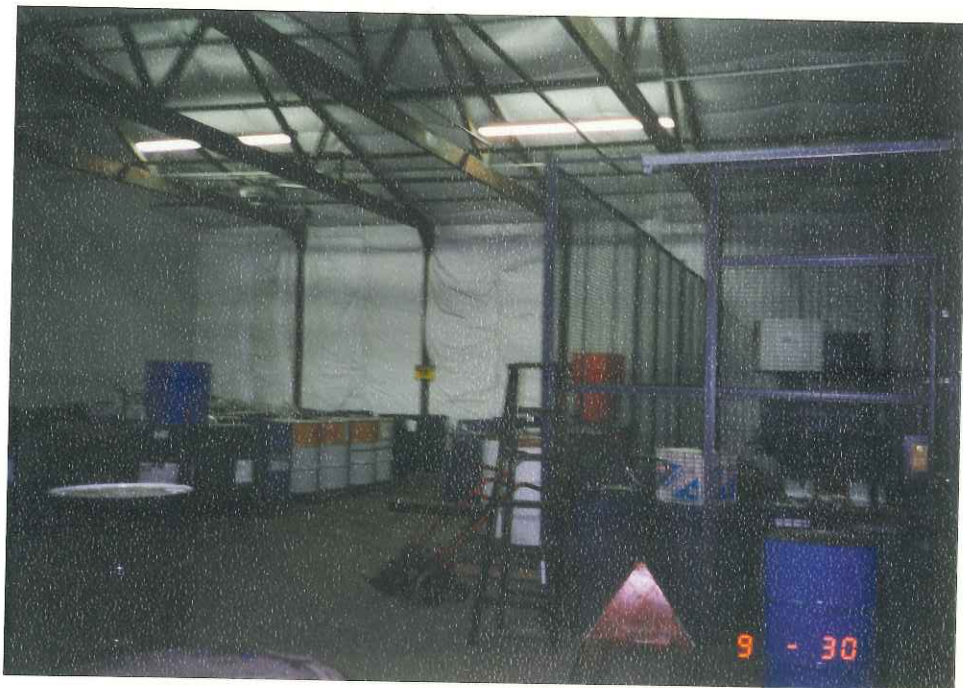
Photograph No.: 3  
Date: January 14, 1993

Description: Overview (180 degrees of photo 2) of the remainder of the flammable materials storage building. 55-gallon drums contain products used in the processes at the facility.

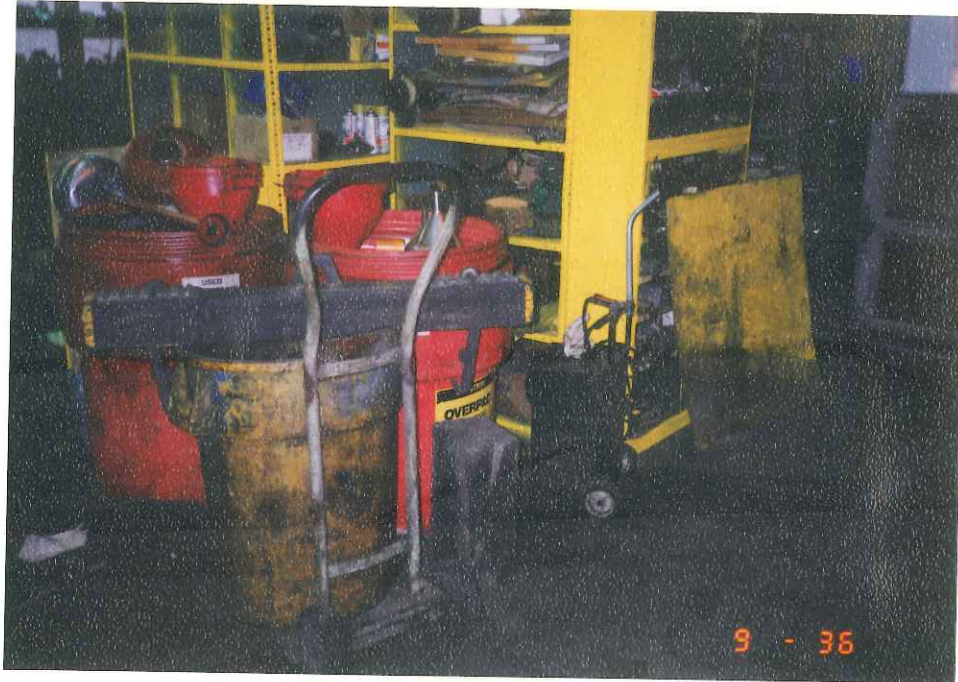
Photograph No.: 4  
Date: January 14, 1993

Description: View of Satellite Accumulation Area (SWMU 3) in the fork truck maintenance garage. Drums are located over concrete, within overpacks. The drums are used for oil and solvent collection.

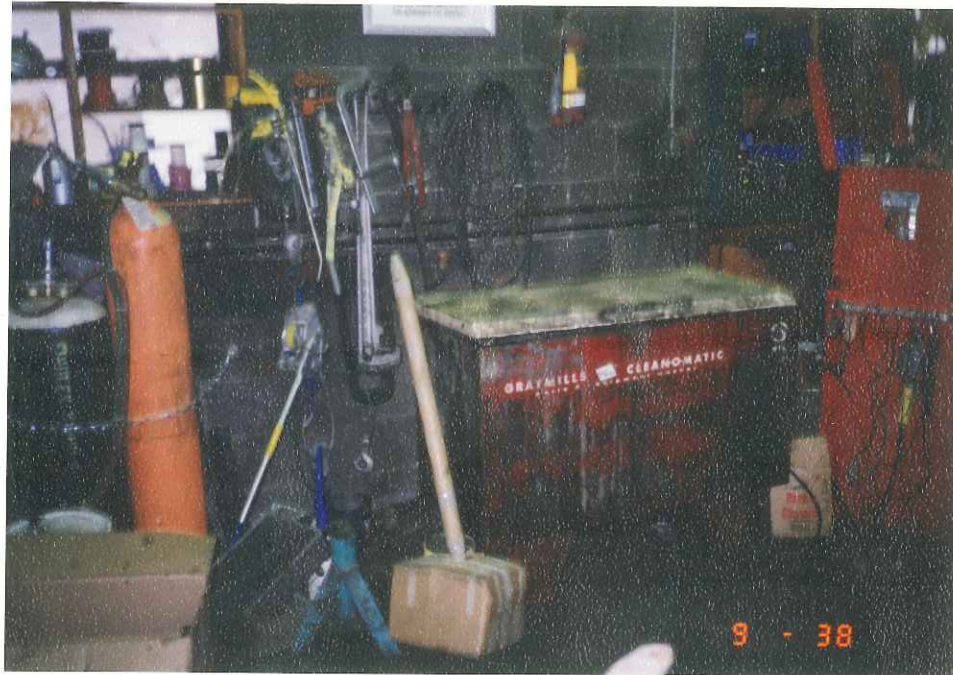
Photograph No.: 5  
Date: January 14, 1993

Description: Close-up view of a solvent Parts Cleaner (SWMU 4) located within the fork truck maintenance building. The unit is located indoors over concrete and contains mineral spirits.

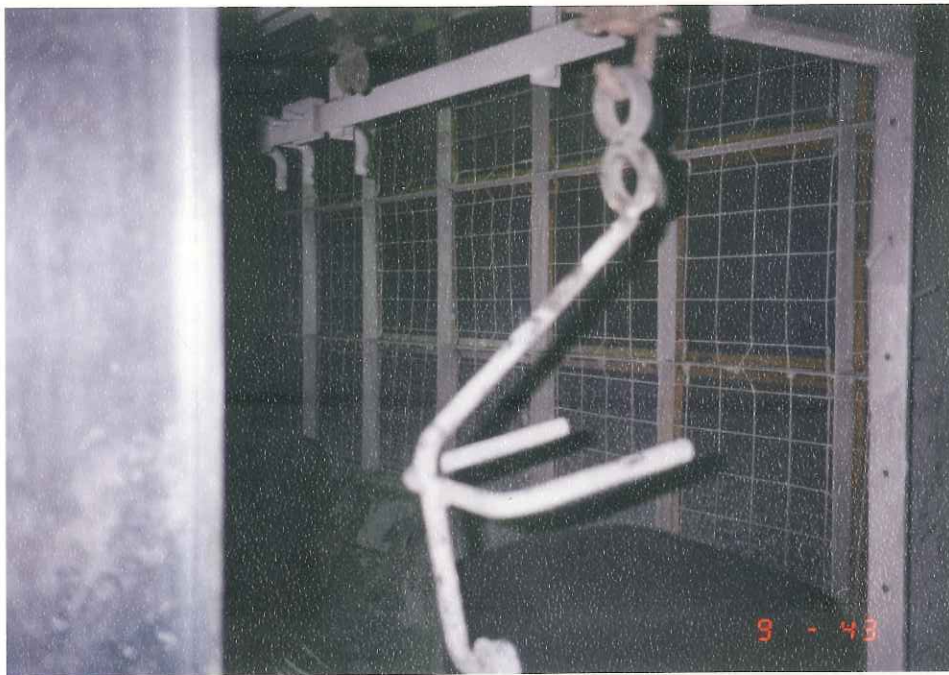
Photograph No.: 6  
Date: January 14, 1993

Description: View of exhaust filtration filters associated with the core wash machine Spray Booth Filter System (SWMU 5) located within the core room of the main production building.

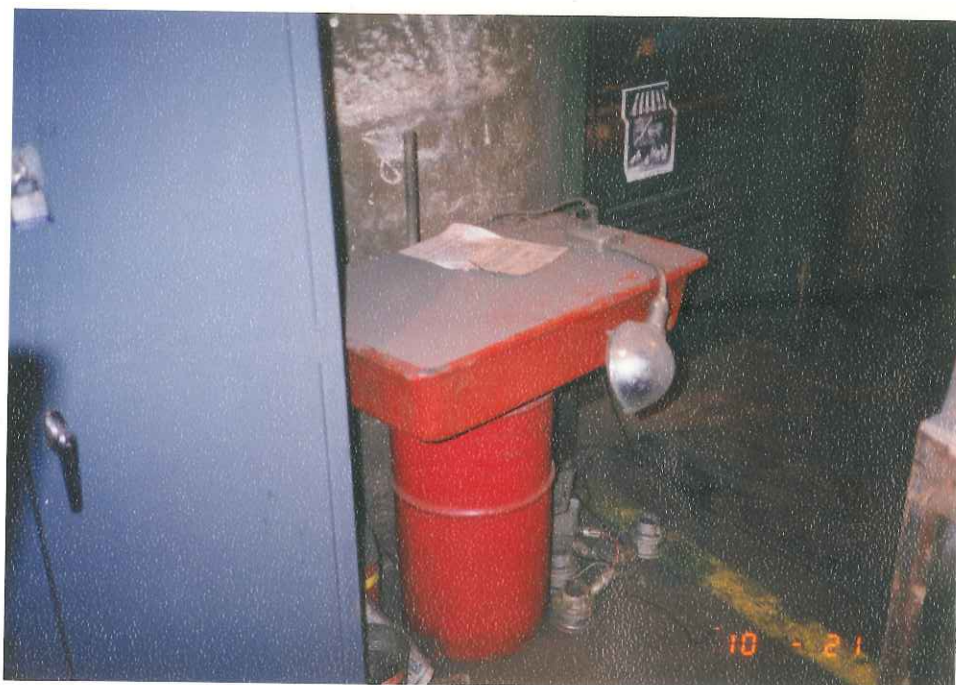
Photograph No.: 7  
Date: January 14, 1993

Description: Close-up view of a solvent Parts Cleaner (SWMU 4) located within the main building at the grinder repair/maintenance location.

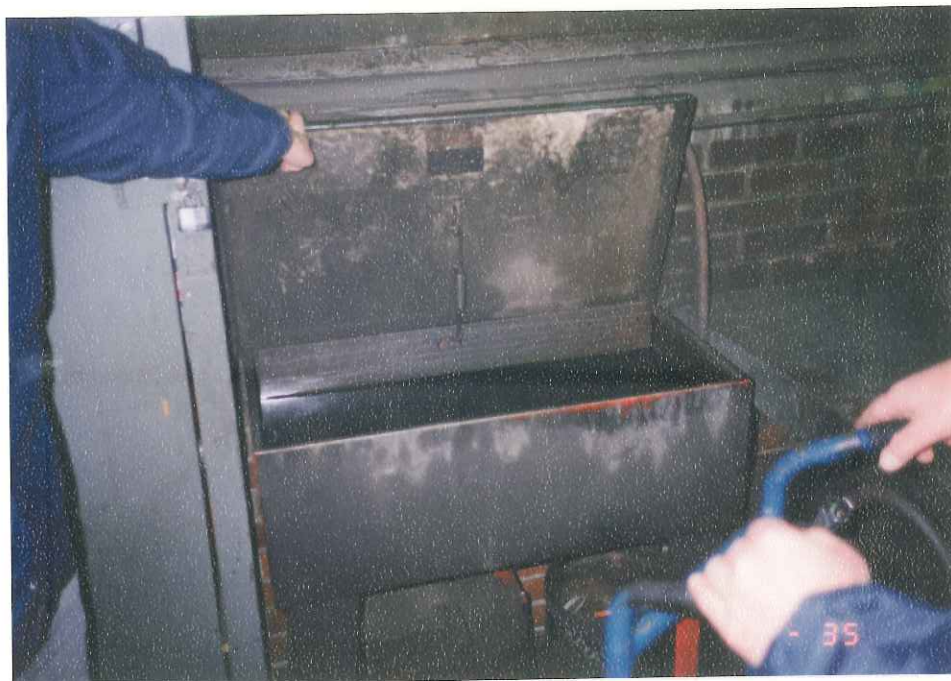
Photograph No.: 8  
Date: January 14, 1993

Description: View of a solvent Parts Cleaner (SWMU 4) located in the south tool room.

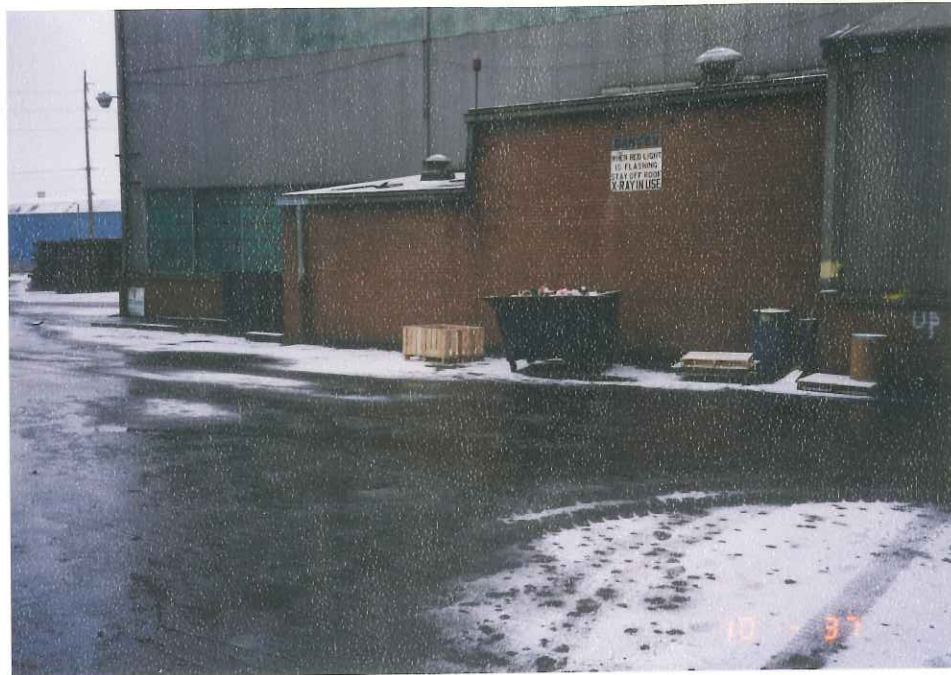
Photograph No.: 9  
Date: January 14, 1993

Description: Overview of a Refuse Dumpster (SWMU 13) outside the facility production building.

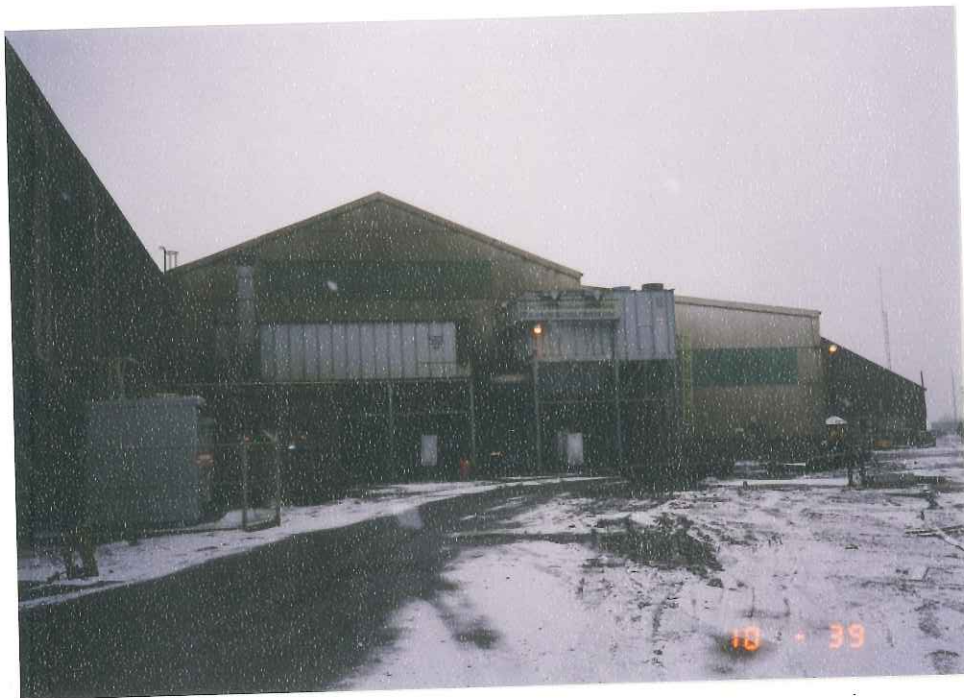
Photograph No.: 10  
Date: January 14, 1993

Description: Overview of Baghouses (SWMU 2) for the blast and rapper operations within the main production building.

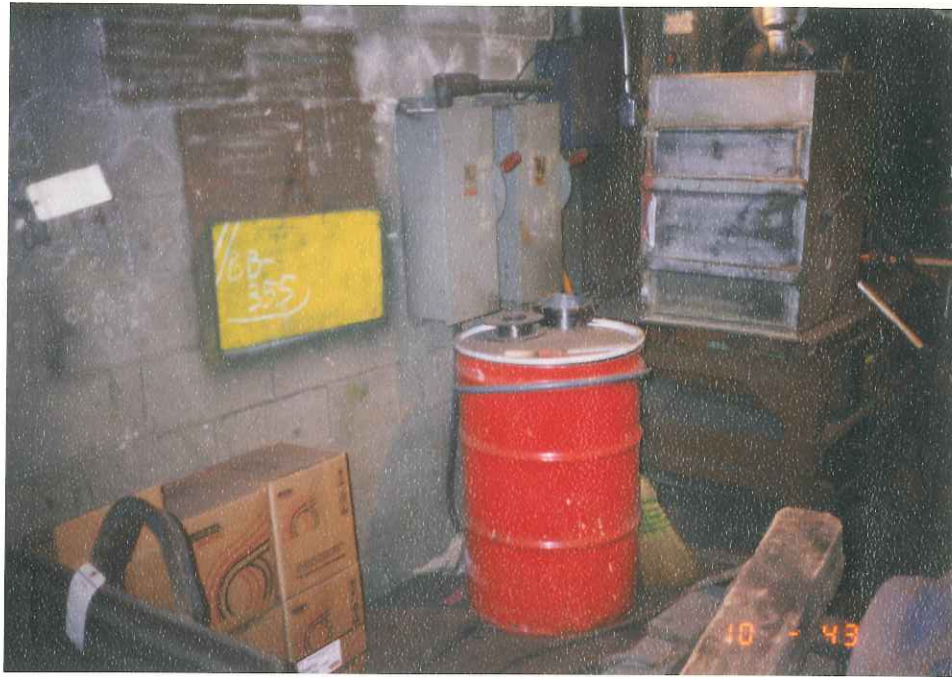
Photograph No.: 11  
Date: January 14, 1993

Description: Close-up view of the wire-feed welder, smoke and dust collector. Note the drum, the Barium Dust Storage Area (SWMU 12), which is used for the collection and storage of dust residues from the collector unit. The collector unit is located adjacent to the drum.

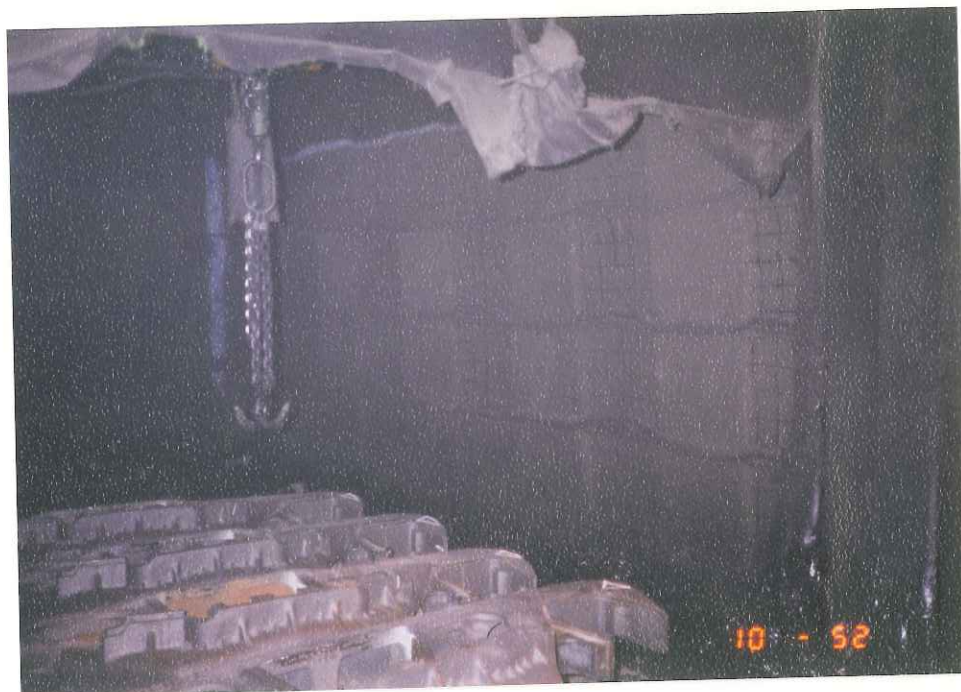
Photograph No.: 12  
Date: January 14, 1993

Description: Close-up view of paint Spray Booth Filter System (SWMU 5) filters. An identical set of filters is located on the opposite wall.

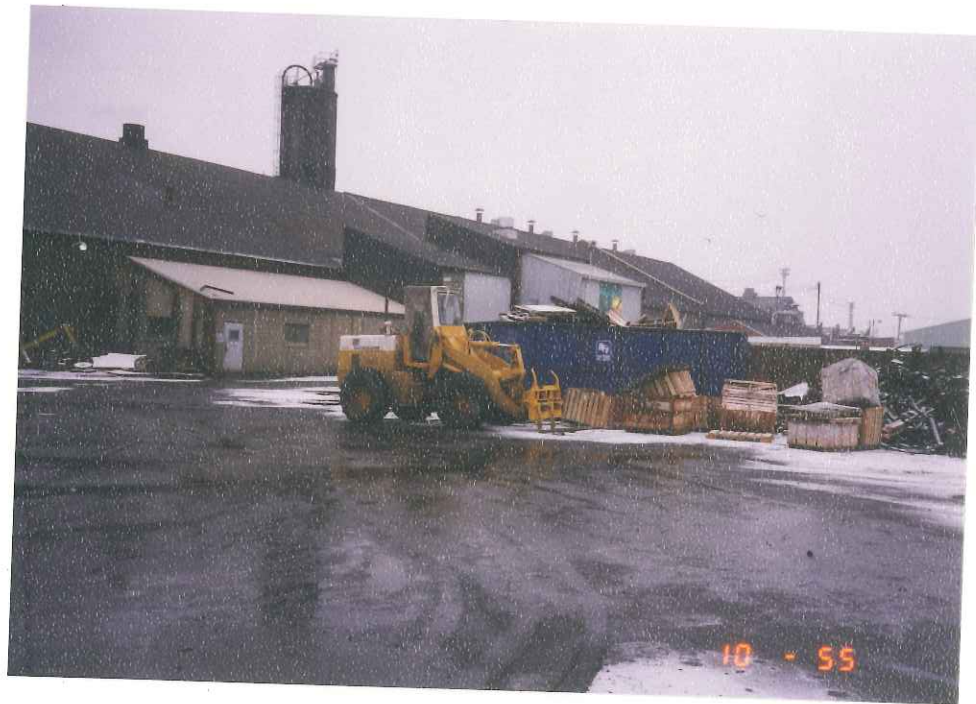
Photograph No.: 13  
Date: January 14, 1993

Description: Overview of Paint Waste and Wood Roll-off Box (SWMU 6).  
Scrap metal to be reused is piled beside the unit.

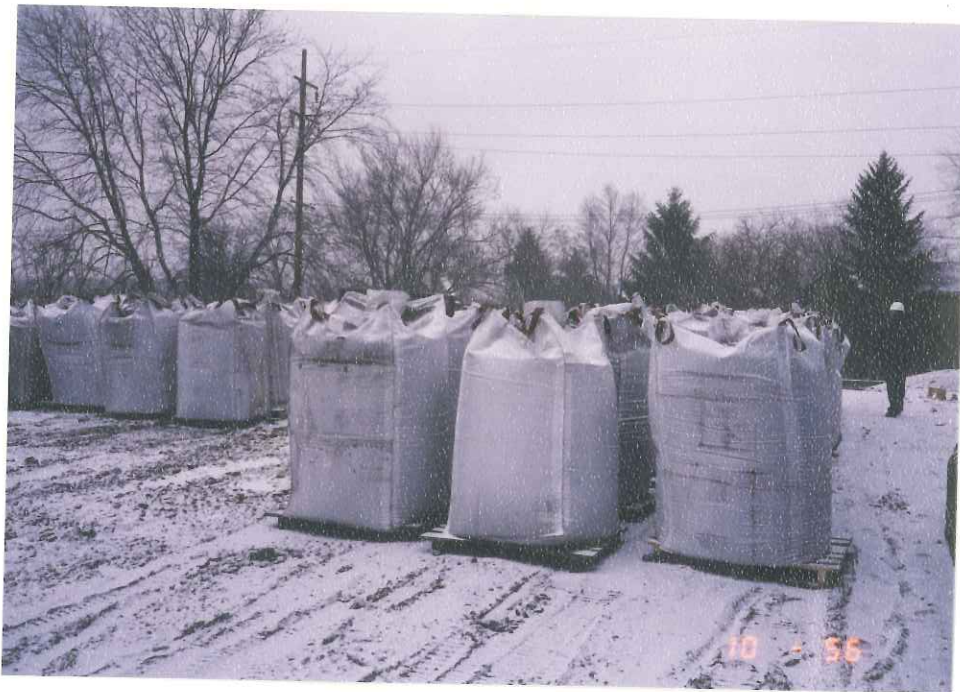
Photograph No.: 14  
Date: January 14, 1993

Description: View of the Baghouse Waste Storage Area (SWMU 11) containing baghouse dust collector bags (full). The bags are set on the ground surface and labelled with origin. This is the former location of paint waste storage.

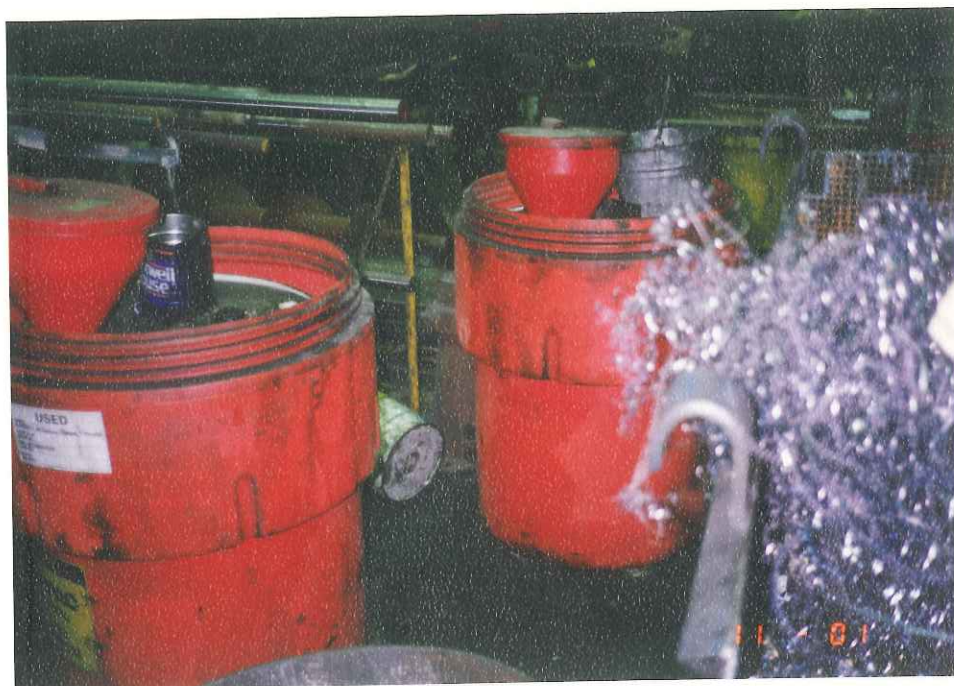
Photograph No.: 15  
Date: January 14, 1993

Description: Close-up view of a Satellite Accumulation Area (SWMU 3) within the B&E building, used for oil and solvent collection.

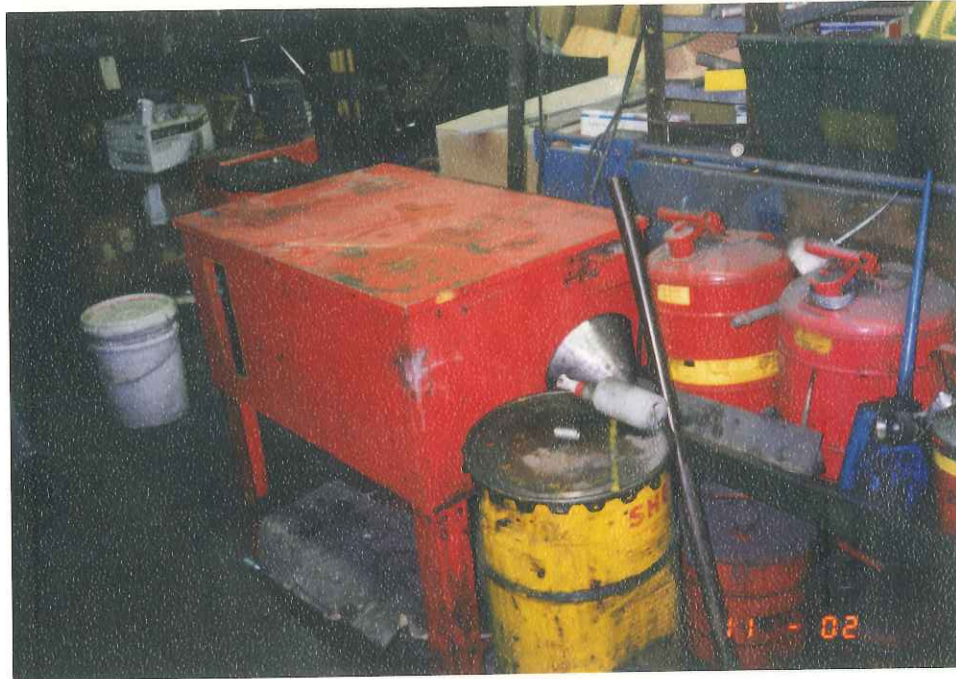
Photograph No.: 16  
Date: January 14, 1993

Description: Close-up view of a solvent Parts Cleaner (SWMU 4) located within the B&E building.

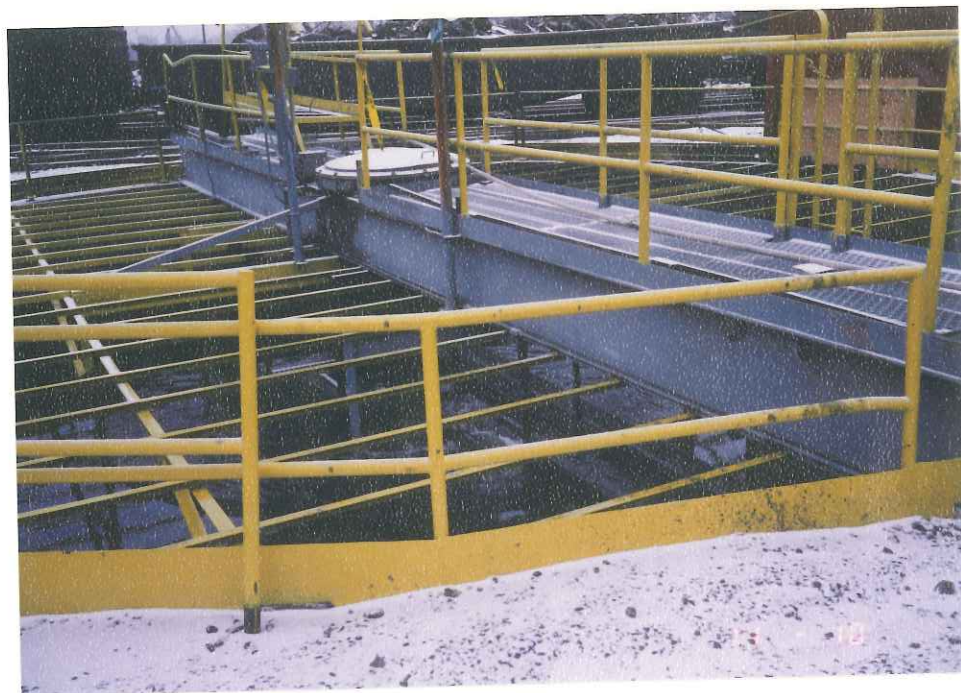
Photograph No.: 17  
Date: August 6, 1992

Description: View of clarifier unit associated with facility Wastewater Treatment System (SWMU 9).

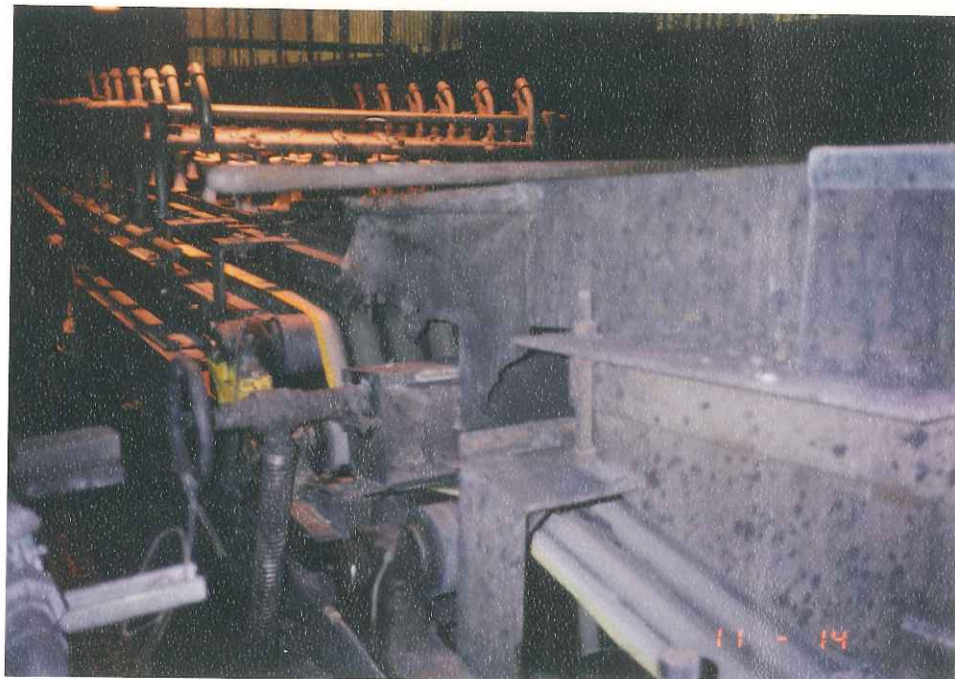
Photograph No.: 18  
Date: January 14, 1993

Description: Close-up view of the filter press used for the dewatering of wastewater treatment sludges, part of the Wastewater Treatment System (SWMU 9).

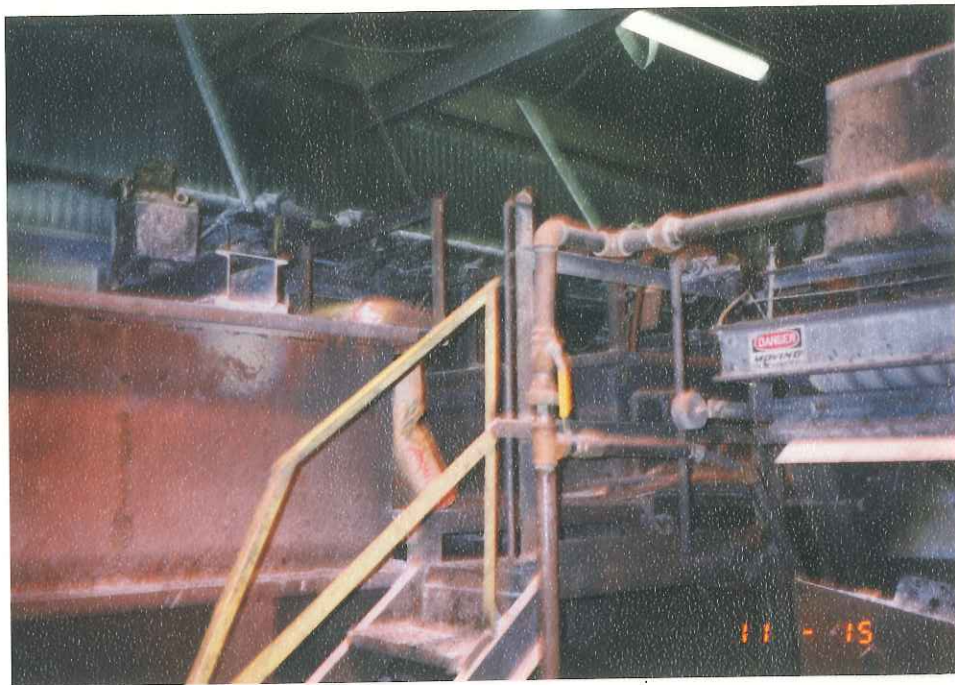
Photograph No.: 19  
Date: January 14, 1993

Description: View of two 3000-gallon sludge holding tanks associated with the Wastewater Treatment System (SWMU 9).

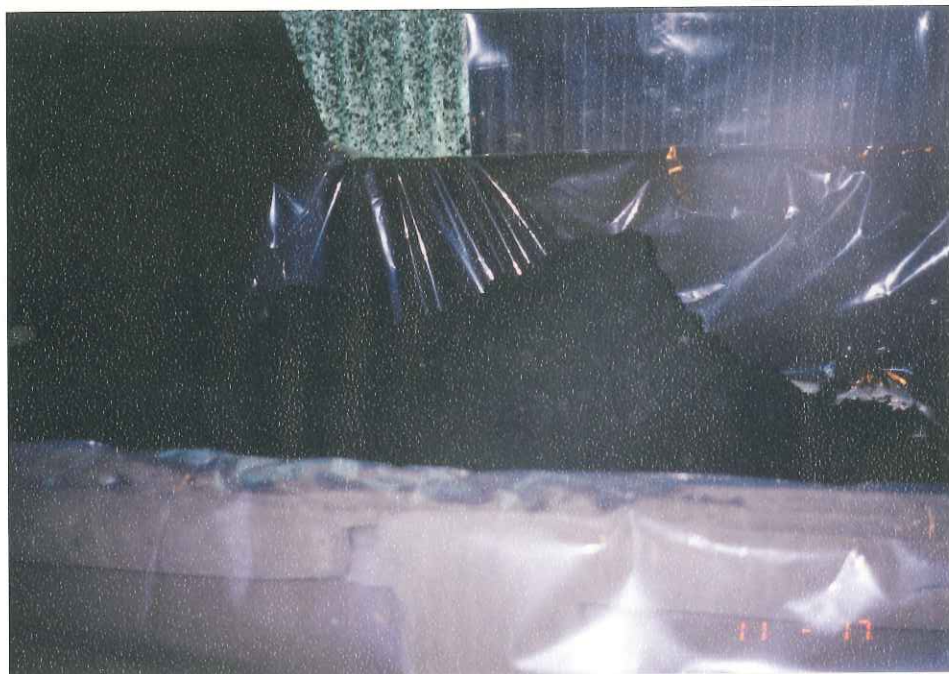
Photograph No.: 20  
Date: January 14, 1993

Description: Close-up view of roll off container (6 cubic yard capacity) used for the storage of dried sludge after pressing, part of the Wastewater Treatment System (SWMU 9).

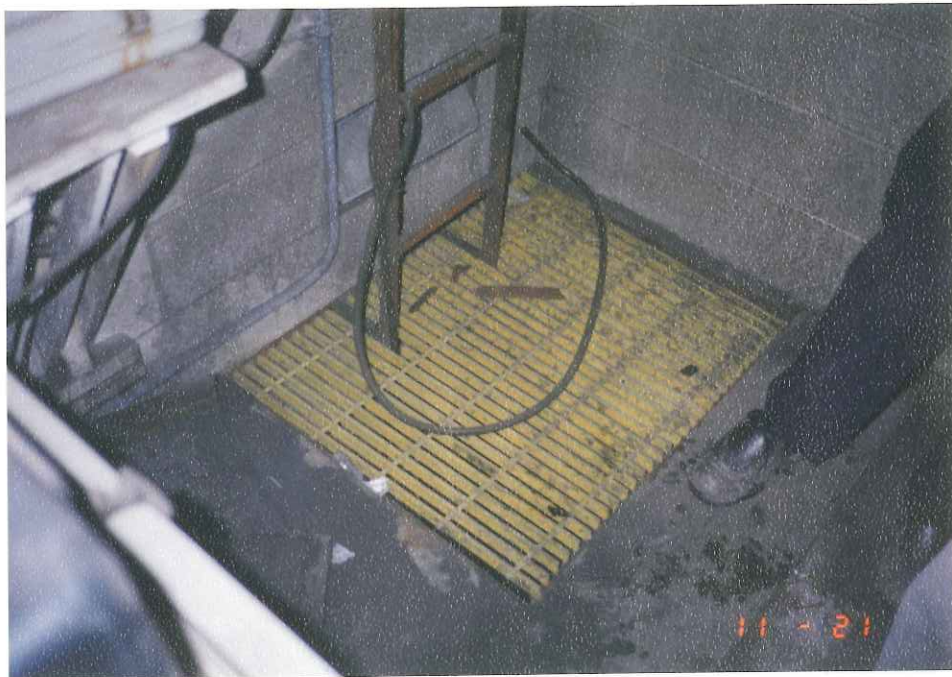
Photograph No.: 21  
Date: January 14, 1993

Description: View of discharge point for treated wastewater from the  
Wastewater Treatment System (SWMU 9) to the city POTW.

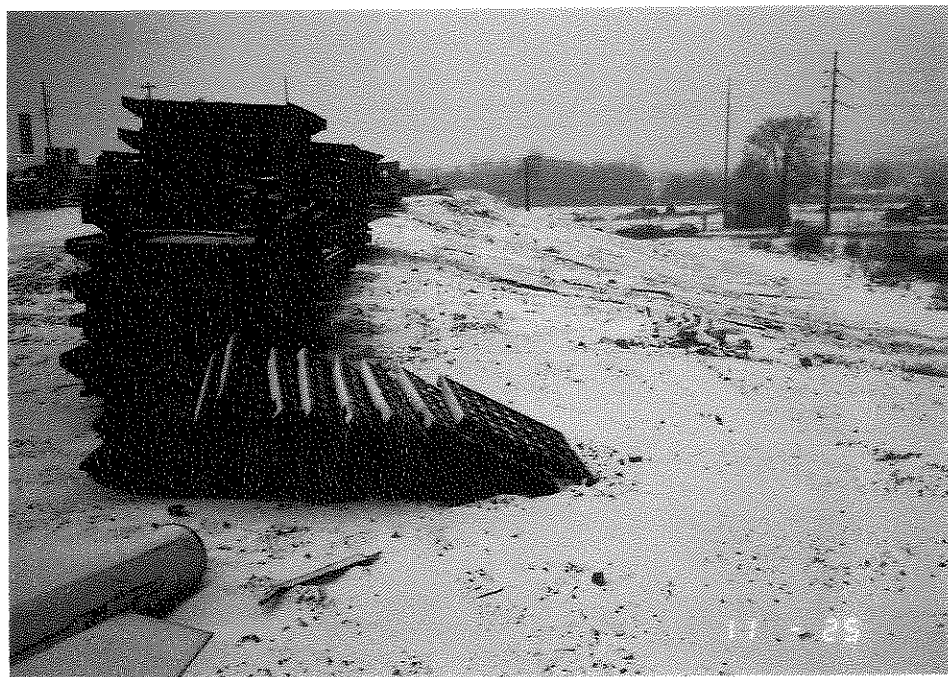
Photograph No.: 22  
Date: January 14, 1993

Description: Overview of the Former East Solid Waste Disposal Area (SWMU 14), now used for scrap steel storage.

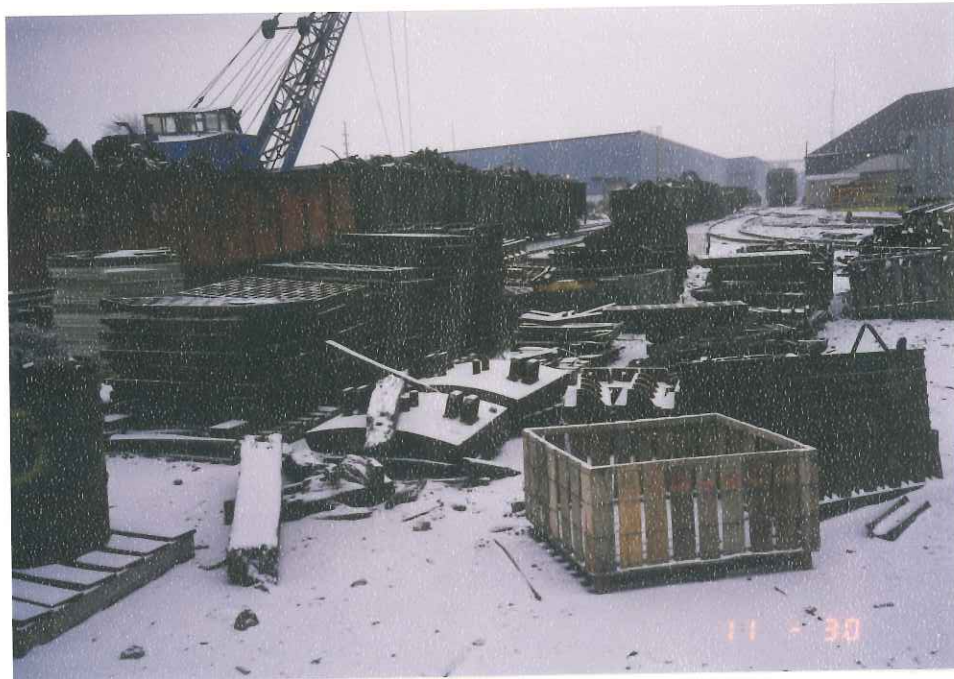
Photograph No.: 23  
Date: January 14, 1993

Description: View of the Former Used Oil Storage Area (SWMU 15), now  
used for scrap steel storage.

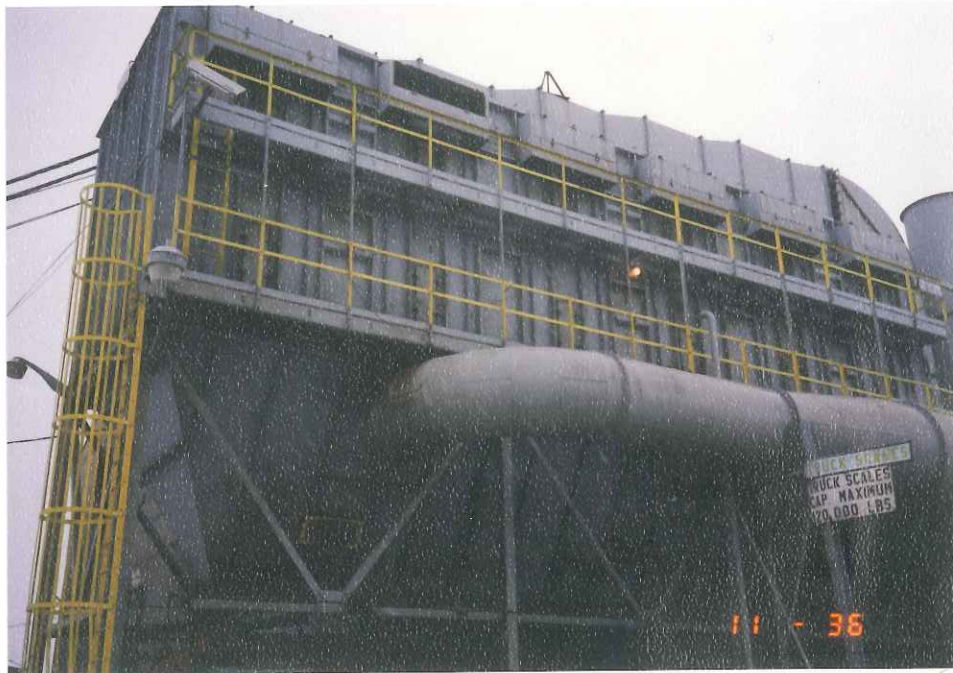
Photograph No.: 24  
Date: January 14, 1993

Description: Overview of the Electric Arc Furnace (EAF) Baghouse (SWMU 8).

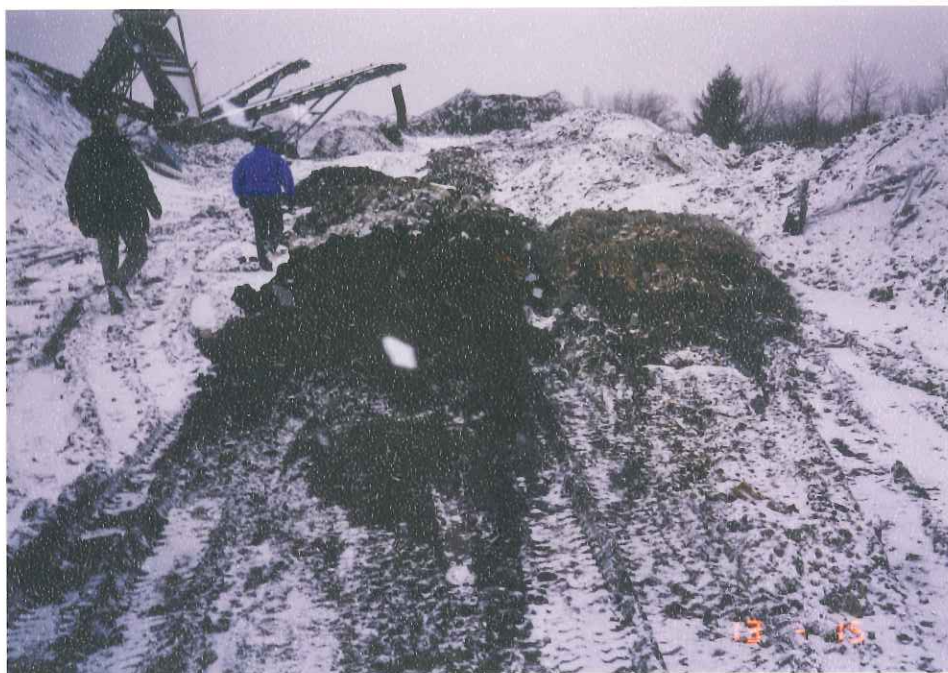
Photograph No.: 26  
Date: January 14, 1993

Description: Overview of waste piles at the ASF Disposal Facility (SWMU 1), separated by material content.

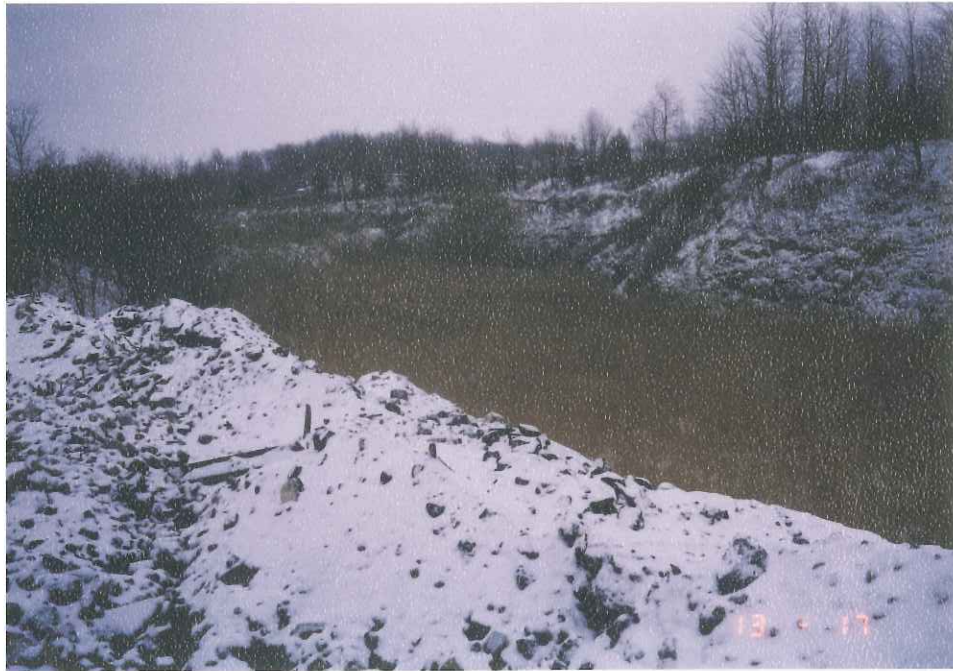
Photograph No.: 27  
Date: January 14, 1993

Description: Overview of the former pond located at the ASF Disposal Facility (SWMU 1) landfill area. This unit no longer contains standing water on a regular basis.

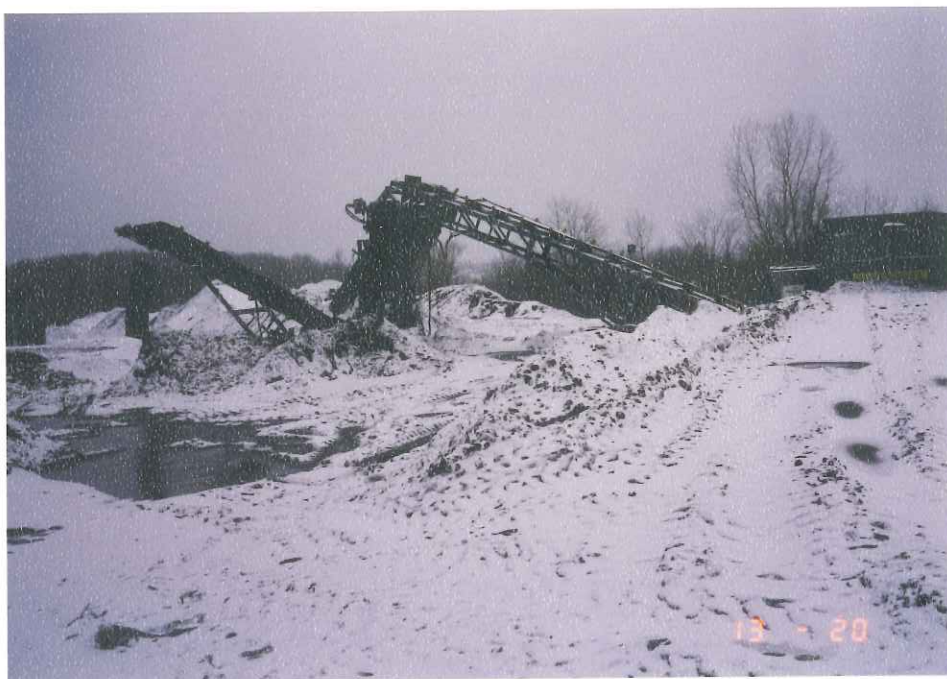
Photograph No.: 28  
Date: January 14, 1993

Description: View of the separation hopper and waste piles at the ASF Disposal Facility (SWMU 1) landfill.

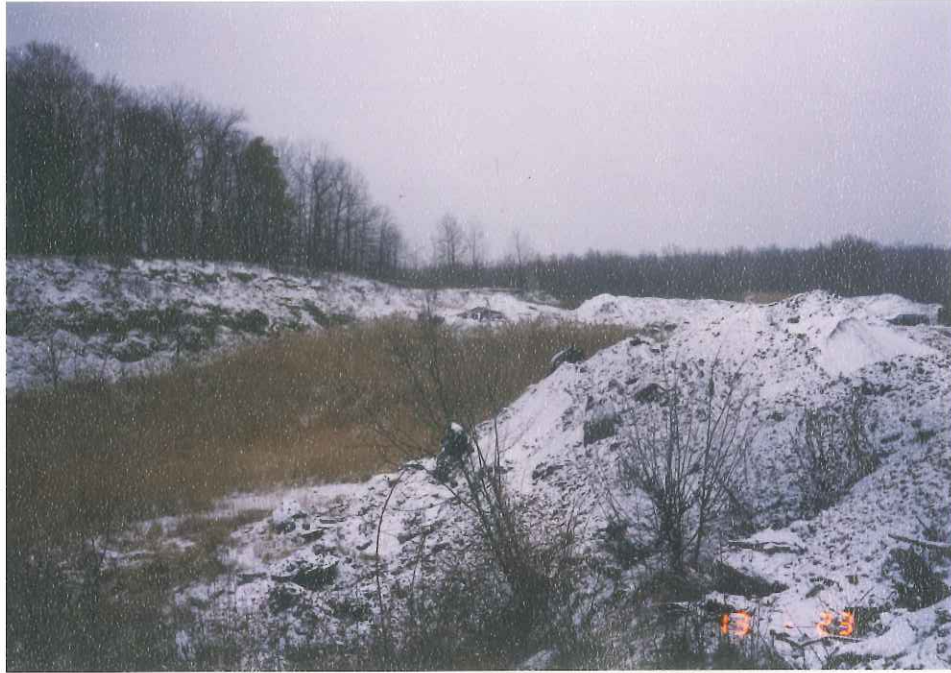
Photograph No.: 29  
Date: January 14, 1993

Description: Overview of former pond and additional ASF Disposal Facility (SWMU 1) land.

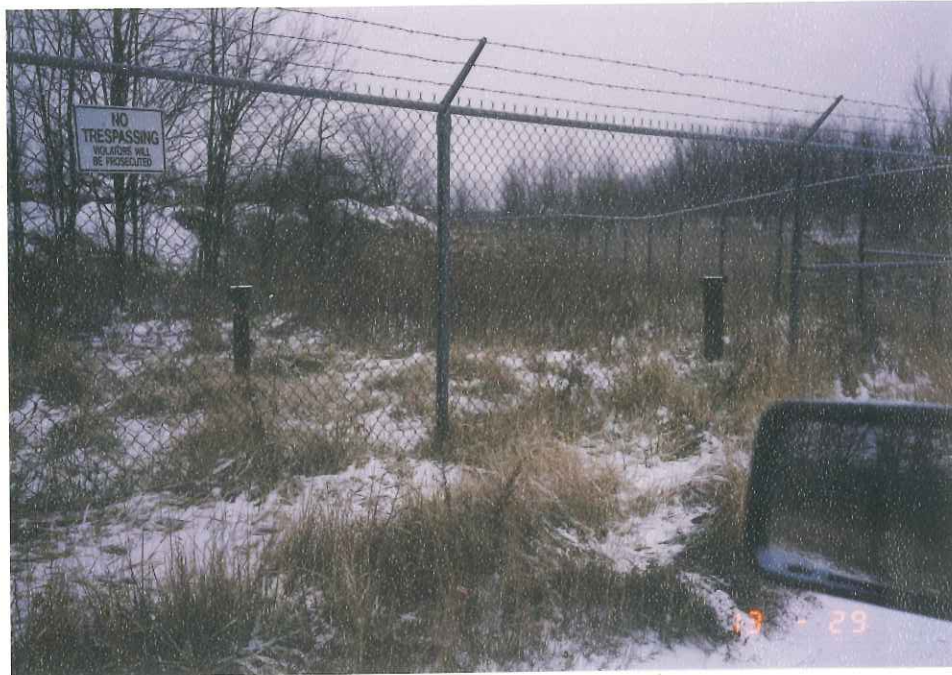
Photograph No.: 30  
Date: January 14, 1993

Description: View of groundwater monitoring wells located at the property boundaries of the ASF Disposal Facility (SWMU 1).

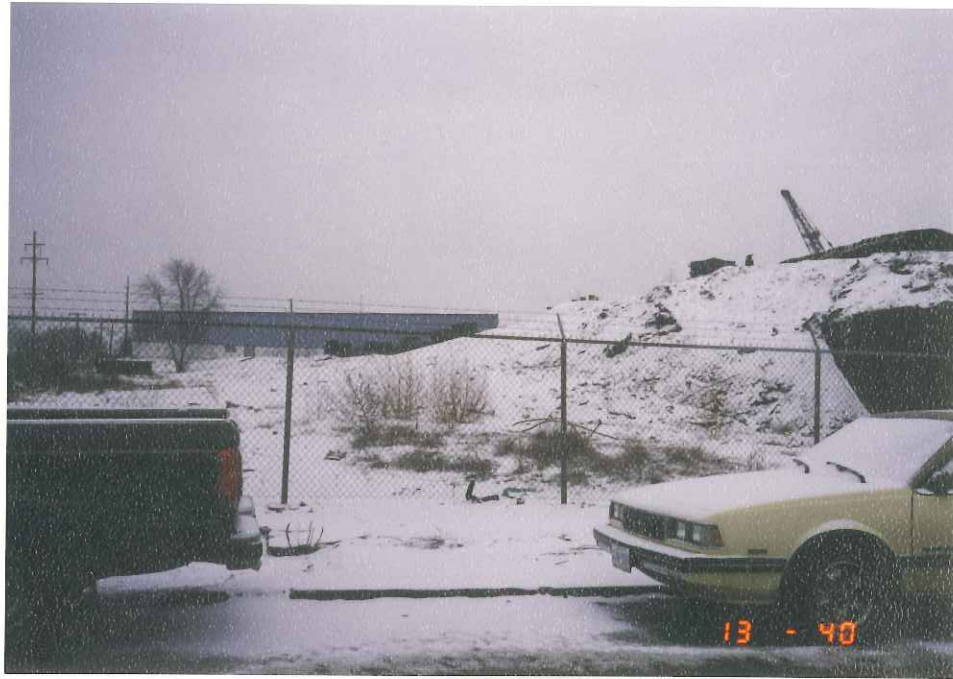
Photograph No.: 31  
Date: January 14, 1993

Description: Overview of the Former East Solid Waste Storage Area (SWMU 14), now used for scrap steel storage.
